# Service Letter

## SL-MD11-001

Type: JS-MD Single  
Model: JS-MD 3 RES

#### 1.B Subject

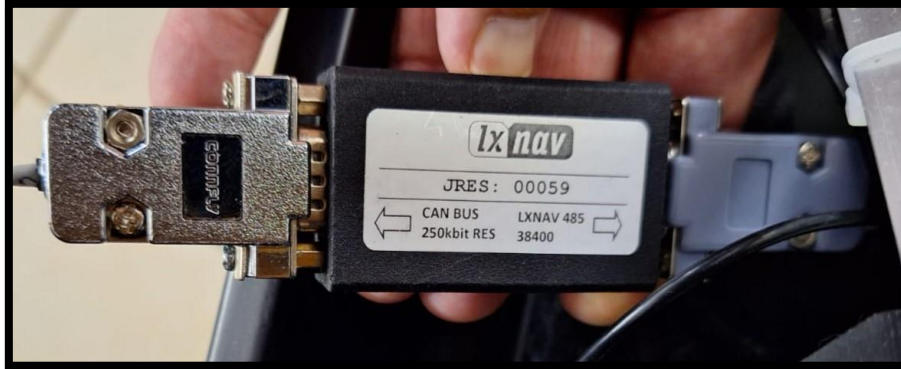
**Figure 1-1: LXNAV JRES Bridge**

LXNav offers an accessory to connect the RES system to the LX90xx flight computer which enables the display of RES information on the flight computer screen. This so-called JRES Bridge can cause communication instability within the RES system.

After thorough investigation, it has been discovered that the RES Bridge contains resistors. These resistors, along with the CANBUS termination resistor housed within the cockpit charge port blind plug, increase the resistance in the CANBUS system. This can potentially trigger error messages such as "No Communication" and result in the absence of data from critical components like RFU, Isometer, Battery A, and Battery B.

These errors can cause instability in the RES system and malfunction.

As a precautionary measure, we highly recommend disconnecting the RES bridge from the DCU before the next flight and informing Jonker Sailplanes Support desk once this has been completed.

1. Remove the canopy and glareshield
2. Locate the bridge behind the instrument panel. (The small black box labeled "LXNav JRES" – refer to **Figure 1-1**)
3. Unscrew the plug connecting to the CANBUS side and the RS485 side of the bridge and remove it
4. Safely stow the plugs and reinstall the glareshield and canopy
