Doc. No.: MD11-WOI-76-001
Type: JS-MD Single	Subject: Service Bulletin	ATA: 76
Model/s: JS-MD 3 RES	Title: Work Instructions for SOLO 8000/400 Firmware Updates	Rev.: 00

Title: Work Instructions for SOLO 8000/400 Firmware Updates
Service Bulletin

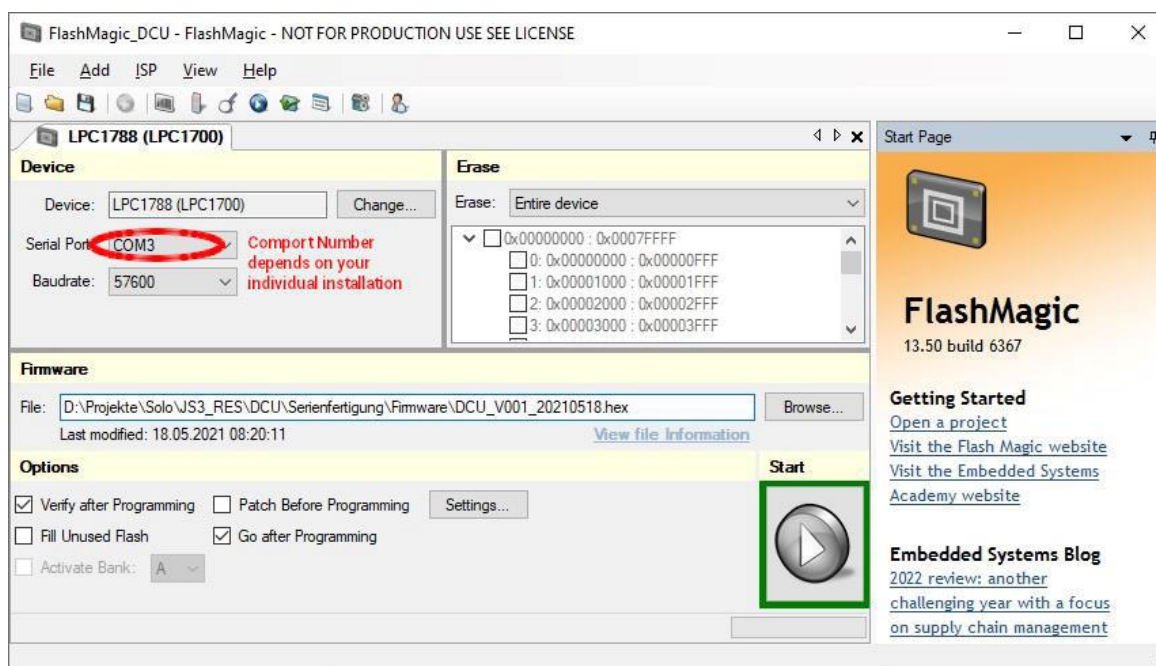
Figure 1: Adjustments to verify

6. Turn propulsion main switch on.
7. Click the large button below the Start icon to initiate the flashing process.
8. Within 10 seconds programming progress should be displayed in footer of the flash magic window. Verify progress as follows:
 - Programming phase - memory address is counting down
 - Verification process - memory address is counting up.
 - When completed - footer is cleared
9. Turn propulsion main switch off.
10. Unplug USB from DCU.

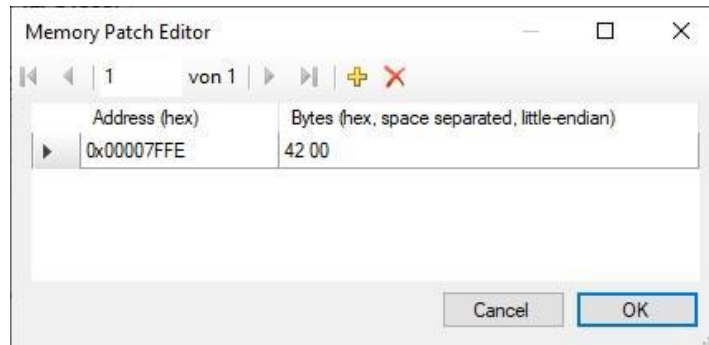
Figure 2: Memory patch editor

The Memory Patch Editor opens. With “+” add a new line with:

- LPC11C24: Address = 0x7FFE and “Bytes” equals the serial number as a 16-bit integer in Hex-“**Little Endian**” format.

- LPC11C22: Address = 0x3FFE and “Bytes” equals the serial number as a 16-bit integer in Hex-“**Little Endian**” format

(This depends on the SN of RFU installed)
